Ophthalmology Times

Nd:YAG laser capsulotomy in intraocular lenses: Safe or dangerous?

Raman spectroscopy, electron microscopy, wavefront measurements offer clues

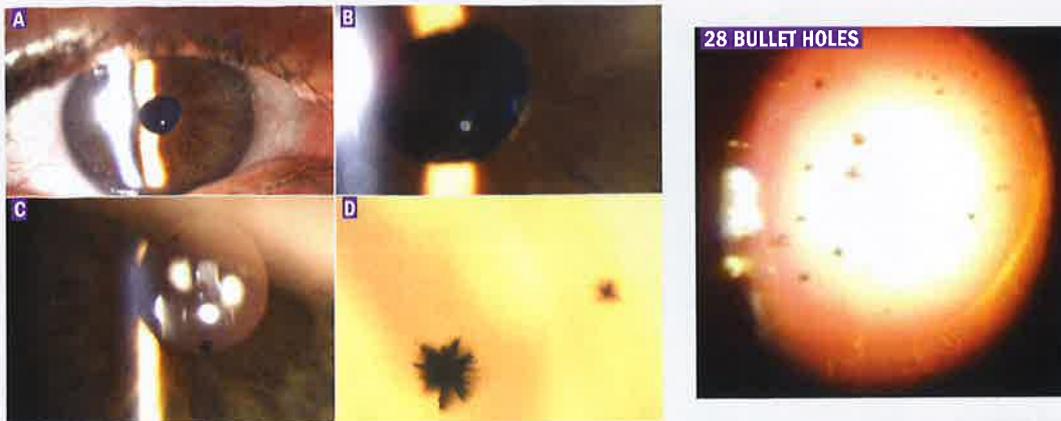
(FIGURE 1) Slit-lamp examination of patients with YAG shots. Note: Some YAG shots are centred in the middle of the lens and visual axis. These patients complained about difficulties (straylight, glare) in night-time driving.

In the past, incorrect and inaccurate focusing of the laser beam was identified as the main cause of pitting. In several cases, time pressure could be determined as the main cause for these iatrogenic defects. Pitting is supposedly not visually significant, although rarely the damage may cause sufficient glare, straylight and image degradation to require the damaged IOL to be explanted (Figures 1–2).

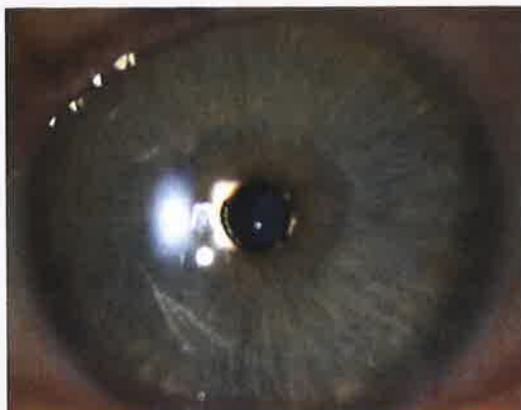
(FIGURE 2) This gentleman observed significantly more glare and problems with night-time driving after capsulotomy. As this was not explained by his physician, he asked for a second opinion. A slit lamp image then revealed central damage in the acrylic, hydrophobic lens.

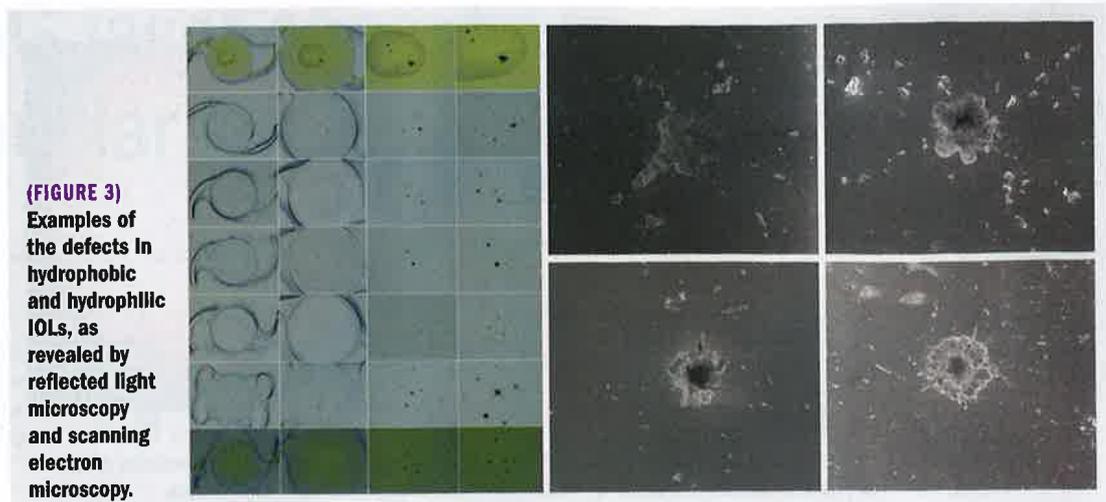
(FIGURE 3)
Examples of the defects in hydrophobic and hydrophilic IOLs, as revealed by reflected light microscopy and scanning electron microscopy.

In photomicrographs of the hydrophilic and hydrophobic IOLs after laser treatment, pits created by the laser were observed on both types of materials. The damage appeared to be bigger and more intense within the hydrophobic lenses than in hydrophilic ones. In the hydrophobic lenses the pits looked similar to the branches that appear when glass breaks and could be seen even with less magnification, while in the hydrophilic ones, they were not as visible.

These smaller zones of damage appeared like bullet holes with a smoother rim. An additional observation was that shots made directly next to already existing defects produced larger craters. This could be caused by a change in the material surrounding the defect (surrounding area).

The ESEM images confirmed the results and showed deeper and greater damage in hydrophobic materials than in hydrophilic. Damage to hydrophilic lenses seemed to be more circular while those in

hydrophobics were more frayed (Figure 3).

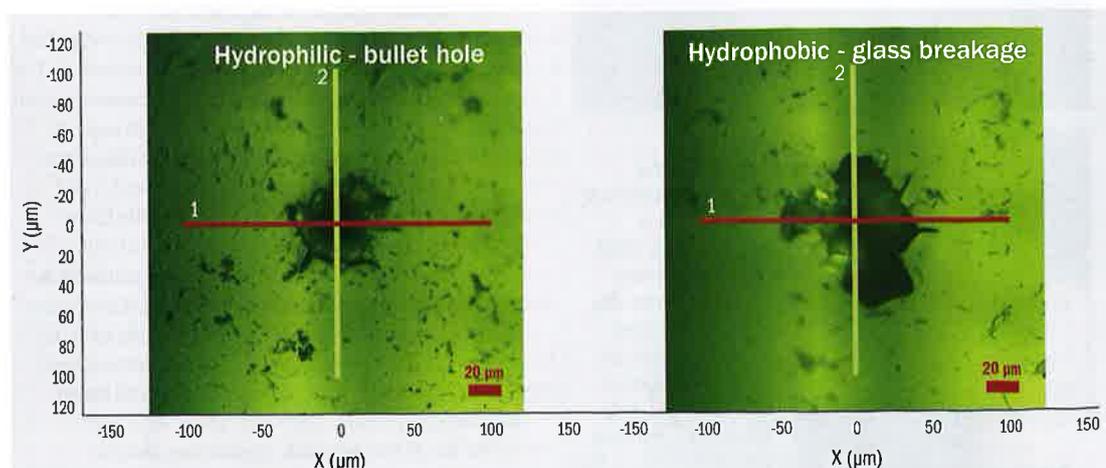
(FIGURE 4) Raman spectroscopy showing the different characteristics of the YAG shots in hydrophilic and hydrophobic materials.

In Raman spectroscopy, defects were found to have different depths, with deeper pits seen in hydrophobic lenses (Figures 4–5). Raman line scans showed the area of defect in terms of chemical changes. These areas were found to be bigger than the visible defect area and, again, this effect was greater in the hydrophobic lenses.

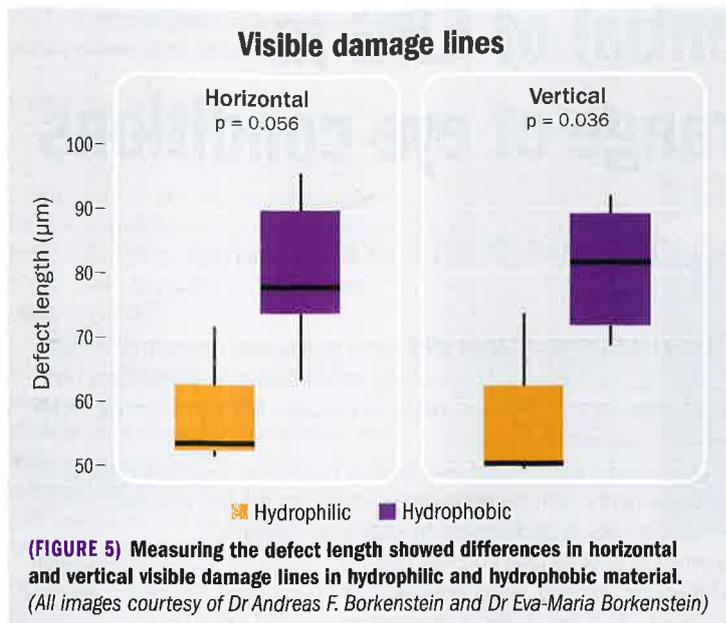
(FIGURE 5) Measuring the defect length showed differences in horizontal and vertical visible damage lines in hydrophilic and hydrophobic material. (All images courtesy of Dr Andreas F. Borkenstein and Dr Eva-Maria Borkenstein)

If we analyse a hydrophobic lens as an example, the visible damage was measured at 81 μm (vertical) and 95 μm (horizontal), however, the chemical changes increased these to 120 μm (vertical) and 124 μm (horizontal), which was an enlargement of 48% and 31%, respectively. This means that the area of the defect in the IOL was not 7,600 μm^2 (visible area) but 14,800 μm^2

(actual area), which meant it was twice as large.
